BACKGROUND

LOCATION	Welshpool, WA
YEAR	2019-2020
INDUSTRY	Material Handling
COMPANY	JOEST Australia
EQUIPMENT	Exciter Test Bed

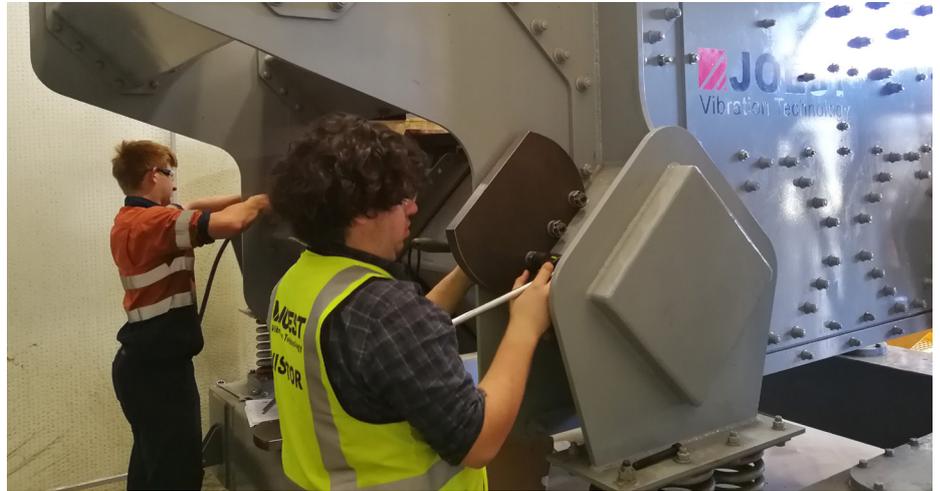
In these tests, the 10.5 Ton screen was operated at or around 830 rpm with an amplitude of 10 mm (other speeds and amplitudes were also tested as JOEST Australia uses the exciter test bed for quality assurance testing different exciters before delivery to customers). This duty cycle results in approximately 7.5 G acceleration at the test piece and 1.2 kN of shear force on the critical joint.

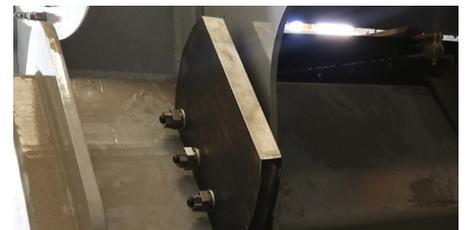
JOINT SECTION

Six 3/4" Cone-lock fasteners were removed and two 23 kg (manual handling limit) steel plates are bolted to either side of the exciter test bed (being approximately 2 m apart). Each plate has three 20 mm holes and is bolted with M16 x 130 mm black 12.9 bolts. Heavy Duty Safety (Belleville) washers are used underneath the Segnuts to minimise non-rotational loosening (relaxing/embedding), with flat F436 washers used under the bolt heads. The Segnuts were tightened to 250 Nm to approximate an 8.8/TF M16 joint as per AS4100 Table 15.2.5.1. No lubricant was used other than the light oil already on the Segnuts.

No nut rotation and no slip/relative movement of the plate was observed after approximately 80 hrs of testing. The failure mode of this type of joint is generally accepted as having a high probability of occurring within the first 15 to 30 minutes of application – once transverse slip occurs; self-loosening can take seconds.
